Kington Recreation Ground Trust

Kington Recreation Ground Trust
Meeting to be held on Monday 6th September 2021
Agenda item 3: Clerk's Report

Kington Rec

22 July 2021

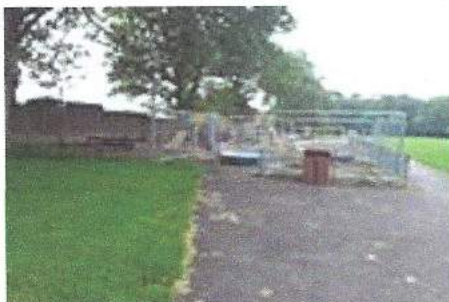
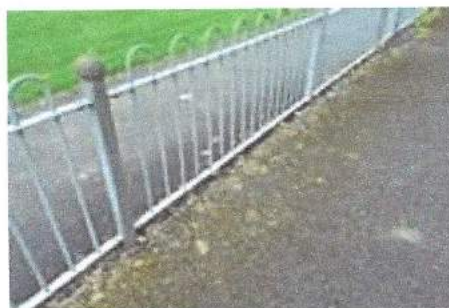
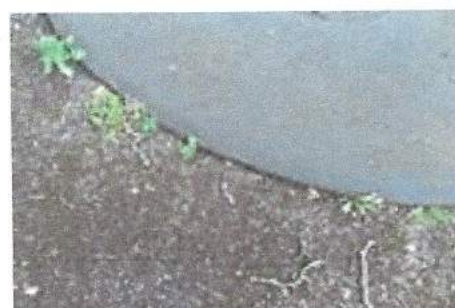
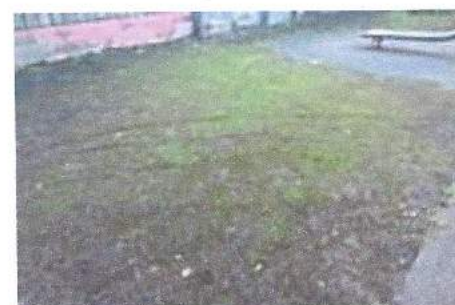
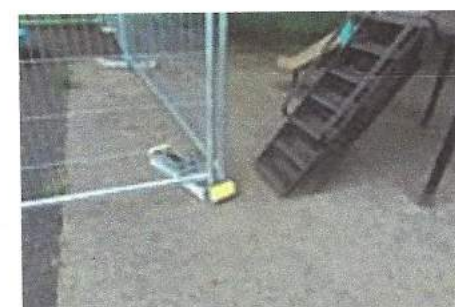
Site General

- 1 There is algae or moss growth on the tarmac surface resulting in slippery conditions
- 2 There are weeds/vegetation growth on, between and around the edges of the surfacing
- 3 The tarmac is breaking up alongside the edgings
- 4 There is algae or moss growth on the safety surface resulting in slippery conditions

- 3 Repair the damaged tarmac

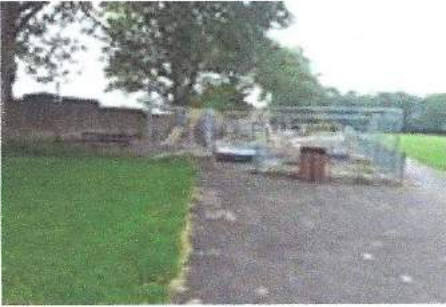
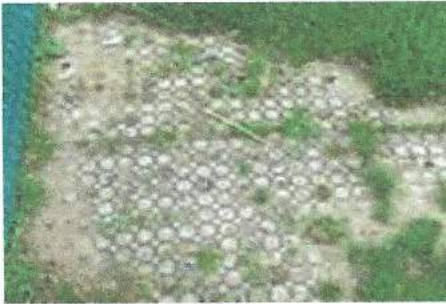
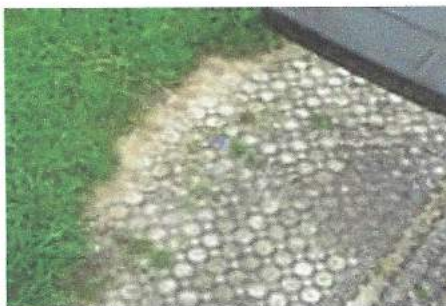
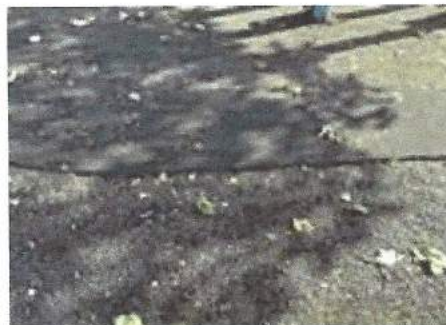
Site General-Continued

- 5 The grass mats are silted up and the soil is compacted; this may have an effect on the impact absorbing properties of the surface
- 6 Fixing Pins have been installed in the impact areas of the grass mats
- 7 The surface is lifting at the edges and creating trip points
- 8 The safety surface is showing signs of wear in some areas

- 7 Repair perimeter of surfacing to remove trip points

- 8 Monitor for any further deterioration and repair as and when required

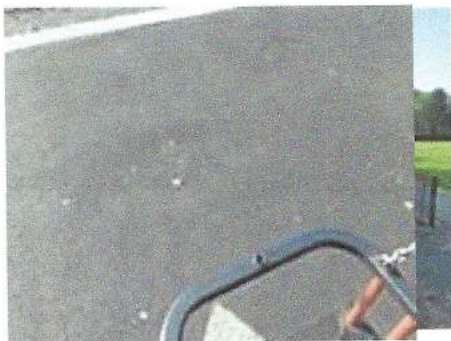
Signs

- 1 It is recommended that information signs with emergency contact details are installed at each entrance/exit point to the playground

- 1 Provide in accordance with the recommendations set out in BS EN 1176

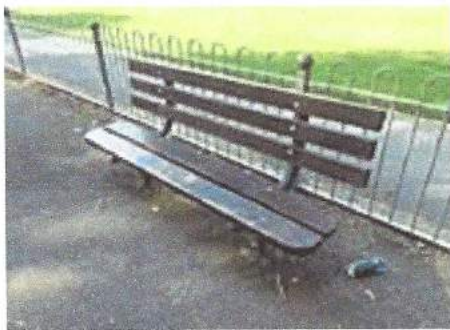
Timber Benches

- 1 The item is satisfactory

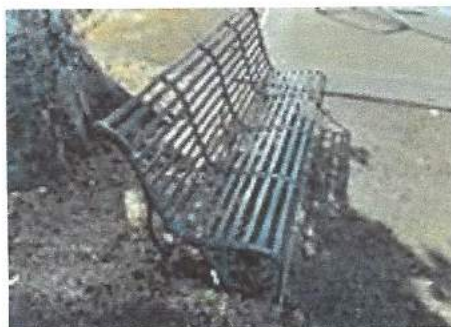
Metal Benches

- 1 The paintwork on this item has been damaged or worn exposing the metal underneath which is rusting

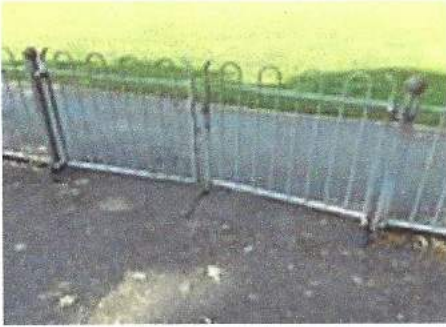
Maintenance Gate

- 1 The gate has no drop bolt sleeves and/or drop bolts fitted
- 2 There is no padlock on the maintenance gate

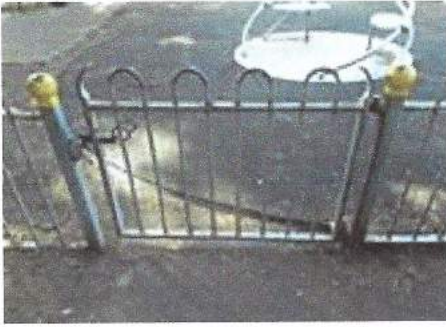
Gates

- 1 The item is satisfactory

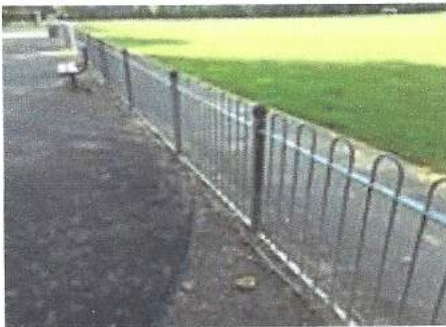
Bow Top ~Fence

- 1 The item is satisfactory

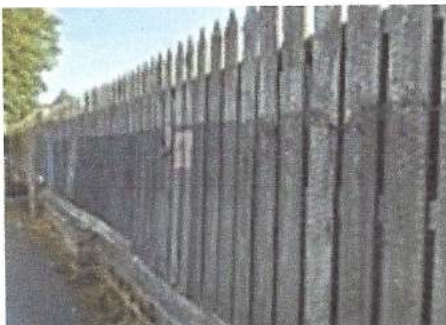
Timber Fence

- 1 There is minor damage to the mesh covering

- 1 Monitor and repair if required

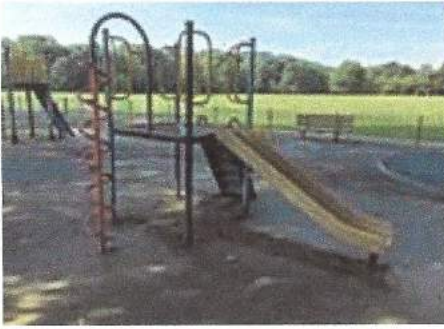
Multiplay Slide

- 1 There are finger entrapments in the framework and the item fails to meet the requirements of BS EN 1176:2008 Part 1 4.2.7.6 Entrapment of fingers
- 2 This item has no slide bar fitted as required by BS EN 1176 Part 3
- 3 The protective covering on the platform has been damaged or worn exposing the metal underneath which is rusting
- 4 The surfacing dimensions do not meet with the requirements of BS EN 1176
- 5 The item has missing component(s)

- 3 Treat any rusting steel and repair the damaged covering

- 4 We consider this to be a low risk finding and no remedial action is recommended - monitor use

- 5 Consider replacing missing components

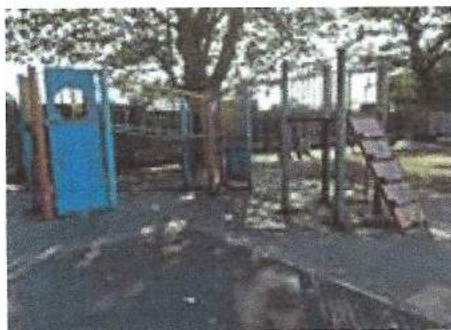
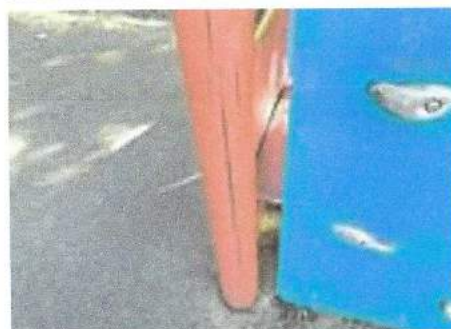
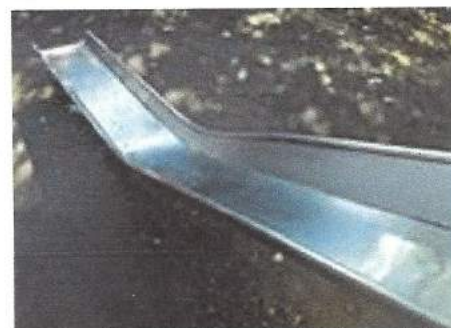
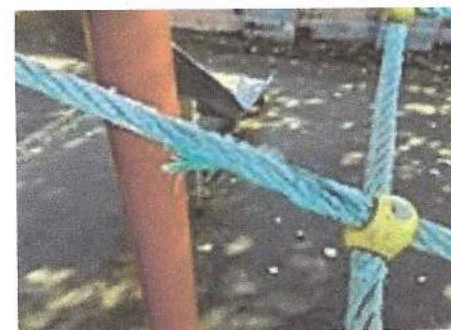
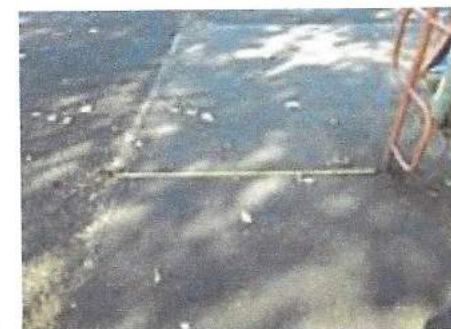
Multiplay Slide

- 1 The timber has a number of splits (shakes) although these are not considered to be a problem at present
- 2 There are a number of dents in the slide surface
- 3 The rope has worn and the wires are exposed
- 4 The surfacing dimensions do not meet with the requirements of BS EN 1176

- 1 Monitor to ensure the splits do not cross through fixing points of the structure and cause any instability

- 2 Monitor for any further deterioration and repair as and when required

- 3 Replace rope or net

- 4 We consider this to be a low risk finding and no remedial action is recommended - monitor use

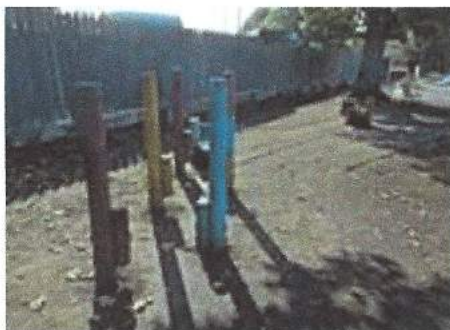
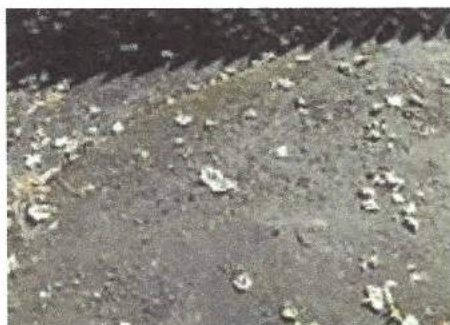
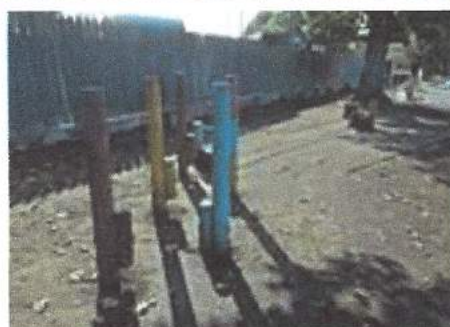
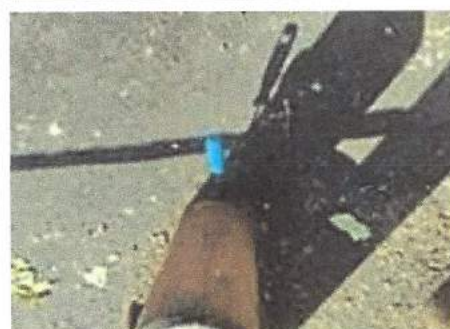
Balance Trail

- 1 The safety surfacing is damaged
- 2 One rope has been removed/missing on this item
- 3 There are areas or parts of the timber on the structure that have rotted

- 1 Repair the damaged areas of surfacing

- 2 Replace the rope

- 3 Replace all affected timbers

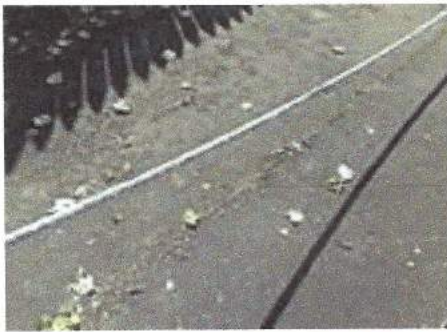
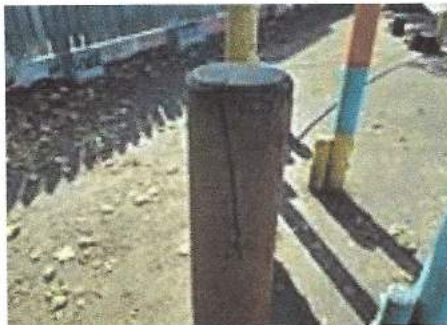
Balance Trail - Continued

- 4 The ropes are worn/damaged in places
- 5 The timber has a number of splits (shakes) although these are not considered to be a problem at present
- 6 There are bolt caps missing

- 4 Monitor for any further deterioration and repair or replace as required

- 5 Monitor to ensure the splits do not cross through fixing points of the structure and cause any instability

- 6 Replace missing bolt caps

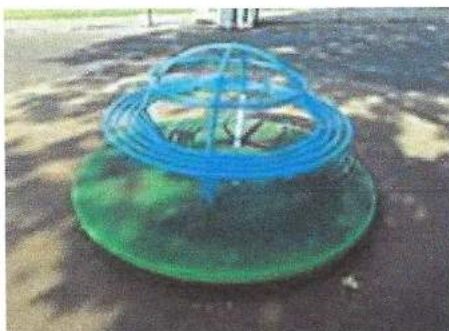
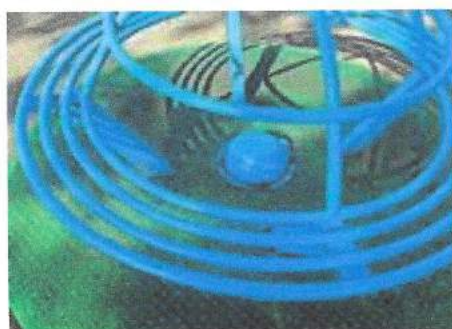
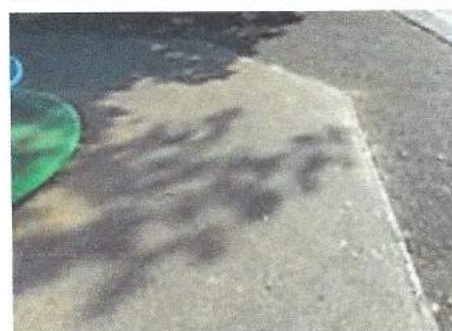
Roundabout

- 1 The bearing is worn
- 2 The distance between the underside of the roundabout platform and the playing surface is less than 60mm and contravenes the requirements of BS EN 1176 Part 5
- 3 The surfacing dimensions do not meet with the requirements of BS EN 1176

- 1 Replace the bearing as required

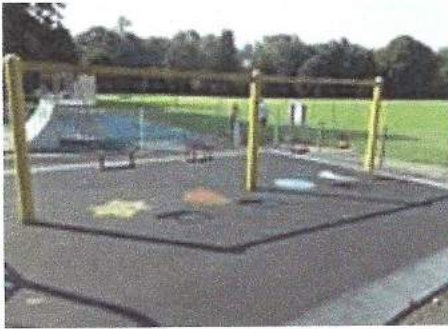
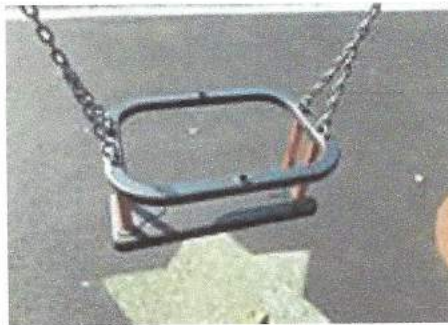
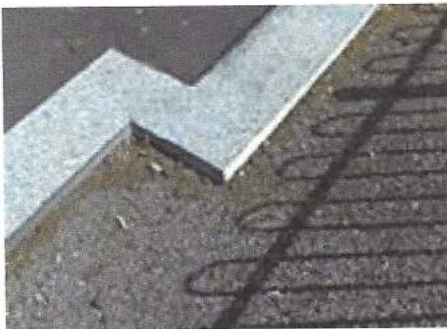
2 Bay Cradle Swing

- 1 The seat is badly damaged
- 2 The paintwork on this item has been damaged or worn exposing the metal underneath which is rusting
- 3 There are trip hazards at the edges of the surface

- 1 Replace seat

- 3 Remove trip hazard

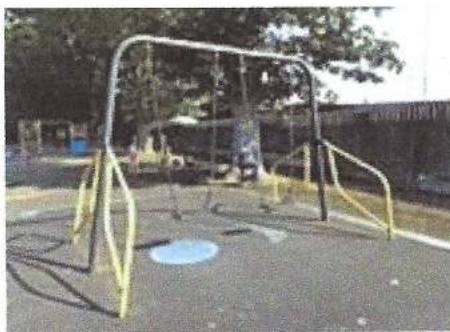
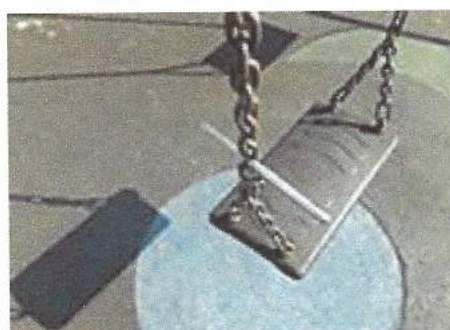
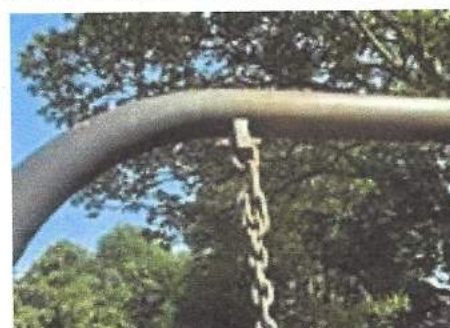
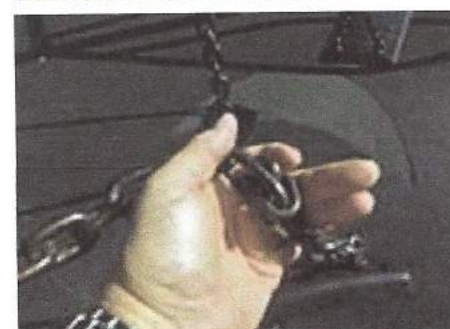
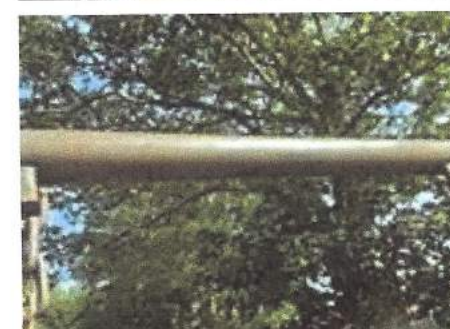
1 Bay Flat Swing

- 1 The chain openings are in excess of the maximum of 8.6mm recommended by BS EN 1176
- 2 The bushes are showing signs of wear
- 3 There is some chain wear
- 4 The paintwork on this item has been damaged or worn exposing the metal underneath which is rusting

- 1 Monitor use and replace with compliant chains during next maintenance cycle

- 2 Monitor for any further deterioration and replace as and when required

- 3 Monitor for any further deterioration and replace when the links are 40% worn

- 4 Treat any rusting components and repaint

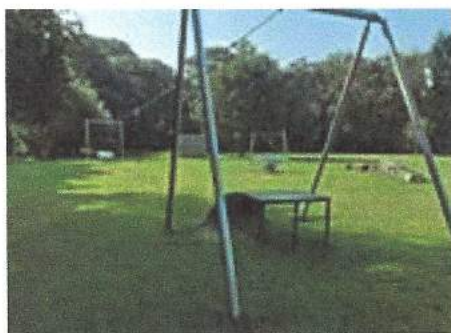
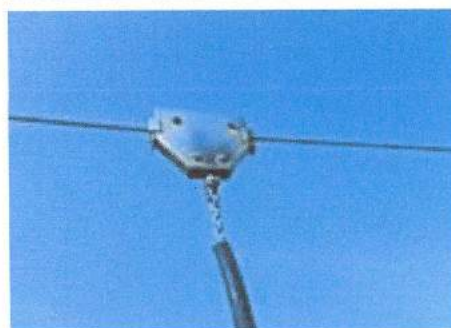
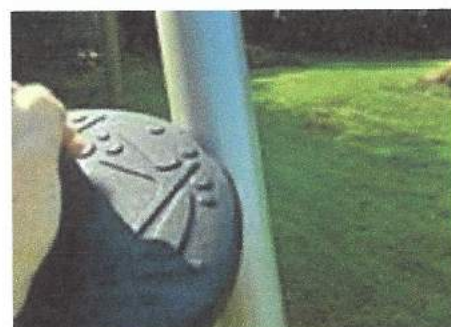
Aerial Runway

- 1 We recommend that the main cable is thoroughly inspected at least once every 2 years this; will involve either removing the cable or gaining access by ladders and/or steps to inspect for damage or internal rusting
- 2 The traveller brake is not working
- 3 The seat is less than 2.0 metres from the post when extended at 45 degrees at the end of the area of travel

- 2 Repair the brake

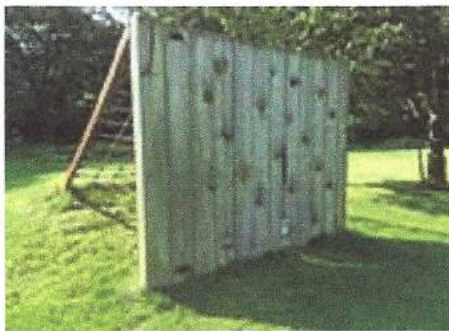
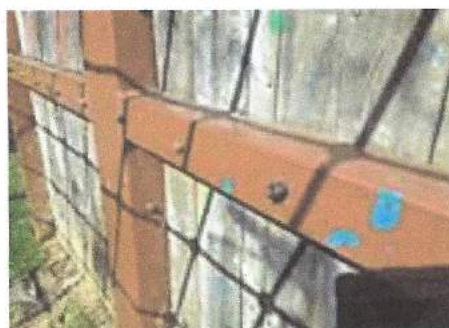
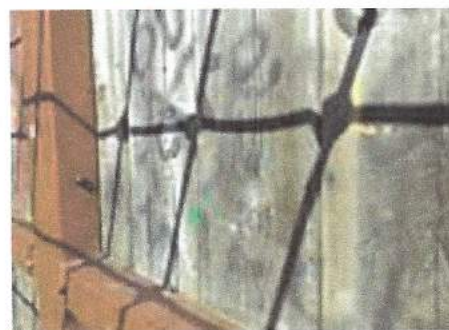
Traverse Wall

- 1 An impact absorbing surface is recommended for this item of equipment
- 2 There are finger entrapments in the timber wall and the item fails to meet the requirements of BS EN 1176:2008 Part 1 4.2.7.6 Entrapment of fingers
- 3 There is/are bolt cap covers missing or damaged
- 4 The timber has a number of splits (shakes) although these are not considered to be a problem at present

- 3 Replace missing or damaged bolt cap covers

- 4 Monitor to ensure the splits do not cross through fixing points of the structure and cause any instability

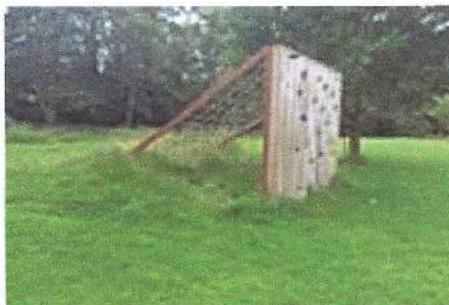
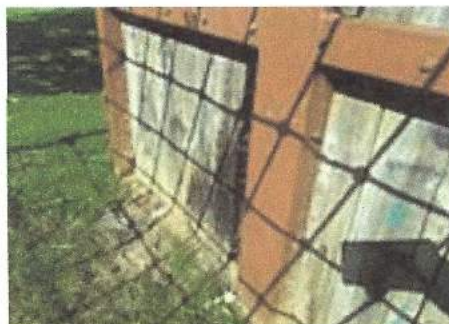
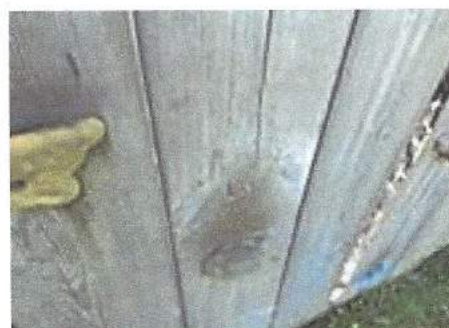
Traverse Wall - Continued

- 5 There is some evidence of fire damage to the item
- 6 There is some damage to timber panel

- 5 Monitor for any further deterioration and repair as and when required

- 6 Monitor for any further deterioration and repair as and when required

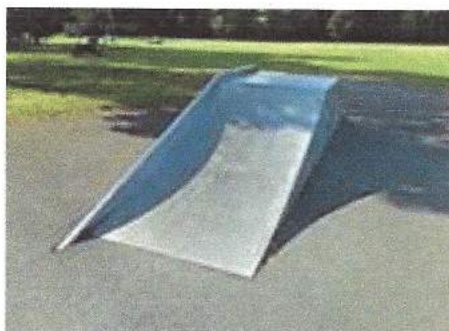
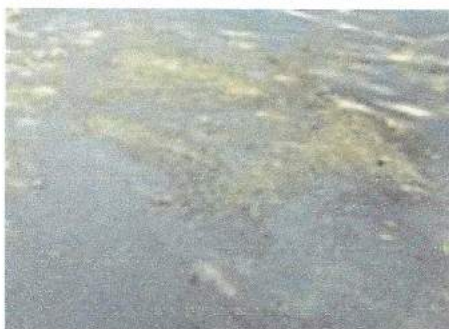
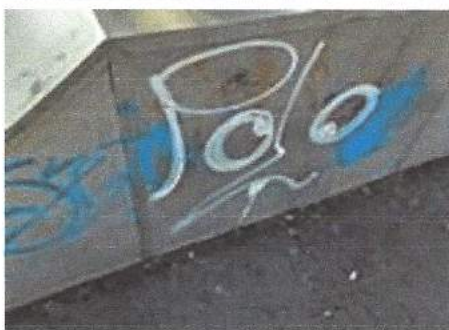
Table Ramp

- 1 The item is constructed using stainless steel which will become hot during the summer months
- 2 There are grass cuttings on the tarmac
- 3 There is graffiti present

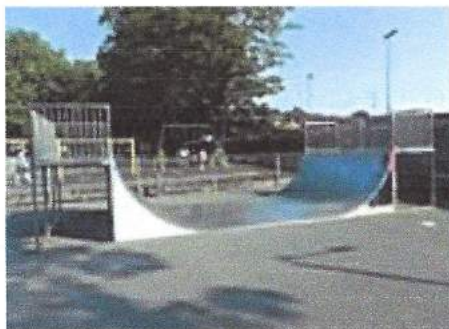
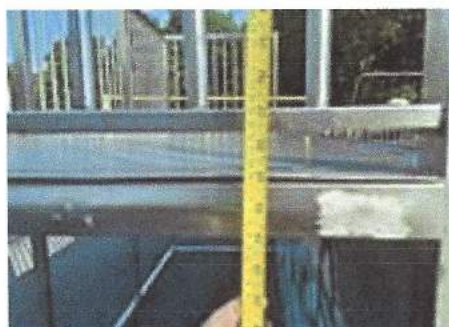
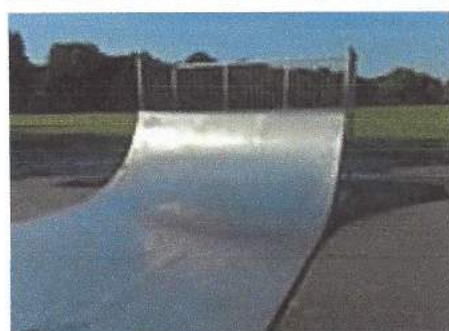
Half Pipe

- 1 The item is constructed using stainless steel which will become hot during the summer months
- 2 The height of the barrier is less than 1200mm and fails the requirements of BS EN 14974
- 3 There is graffiti present
