Kington Recreation Ground Trust

Kington Recreation Ground Trust
Meeting to be held on Monday 6th September 2021
Agenda item 3: Clerk's Report

Kington Rec

22 July 2021

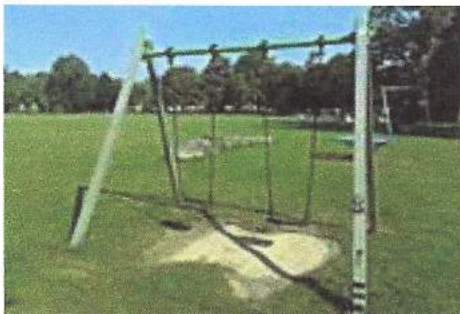
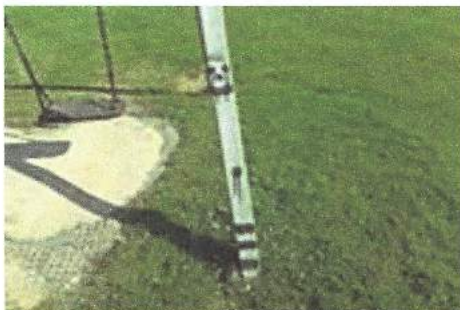
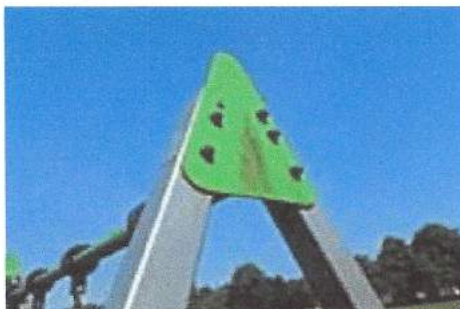
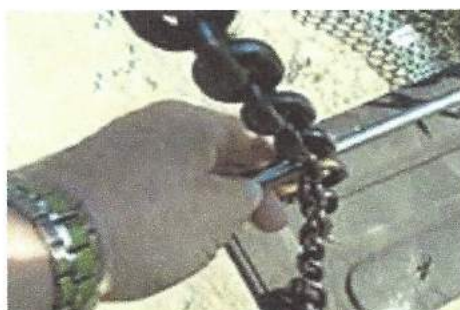
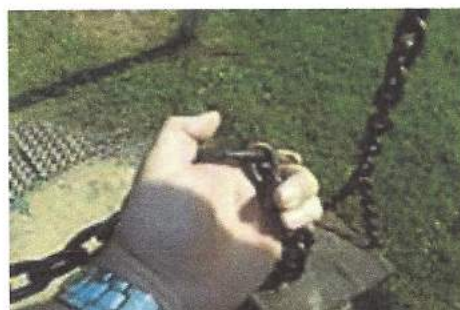
1 Bay Flat Swing

EN1176 Compliance: No
